# Uniform Mitigation Verification Inspection Form

| Owner Name: HIDDEN CREEK CONDOS | CASE#: 20211103-WMIR-04 | Contact Person: JORGE AGUILO |
| Address: 1610 - 1622 SHADY RIDGE CT - BLDG 36 | | Home Phone: |

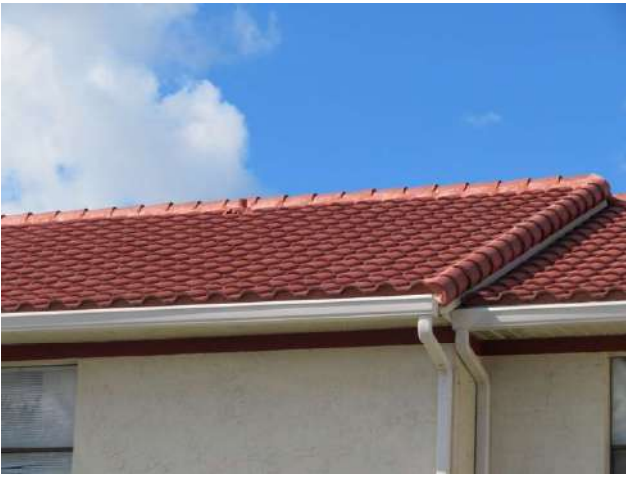
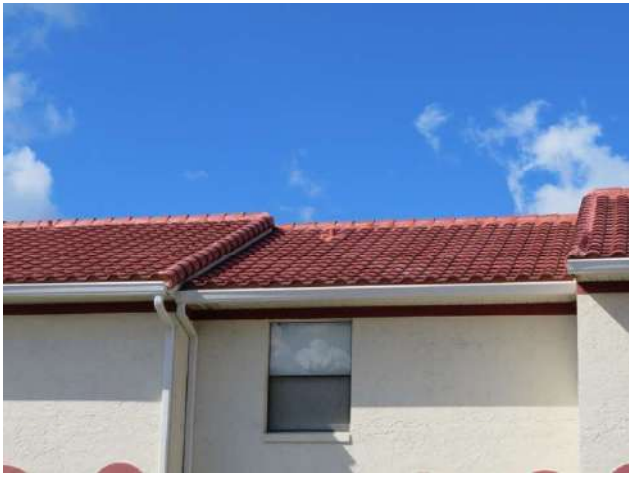
ROOF

| 2.1 Roof Covering Type: | Permit Application Date | FBC or MDC Product Approval # | Year of Original Installation or Replacement | No Information Provided for Compliance |
|---|---|---|---|---|
| <input checked="" type="checkbox"/> 2. Concrete/Clay Tile | 04/07/21 | _____ | _____ | <input type="checkbox"/> |

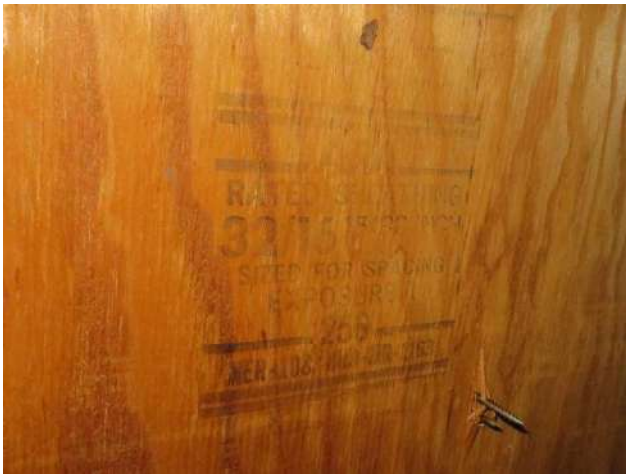
- ☒ C. Plywood/OSB roof sheathing with a minimum thickness of 7/16" inch attached to the roof truss/rafter (spaced a maximum of 24" inches o.c.) by 8d common nails spaced a maximum of 6" inches in the field. -OR- Dimensional lumber/Tongue & Groove decking with a minimum of 2 nails per board (or 1 nail per board if each board is equal to or less than 6 inches in width). -OR-

SHEATHING - 1/2" PLYWOOD

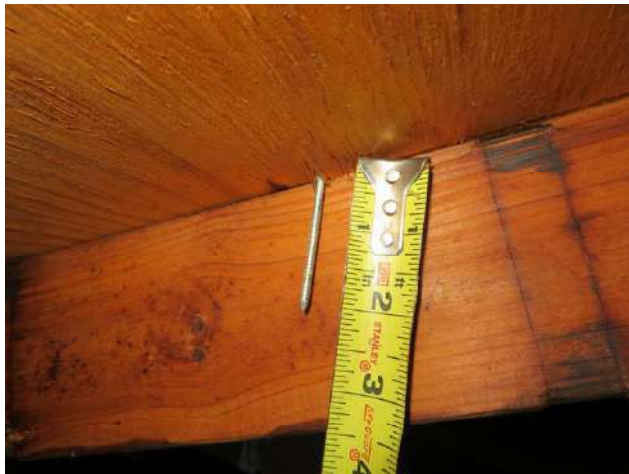
NAIL ATTACHMENT - 8D NAILS

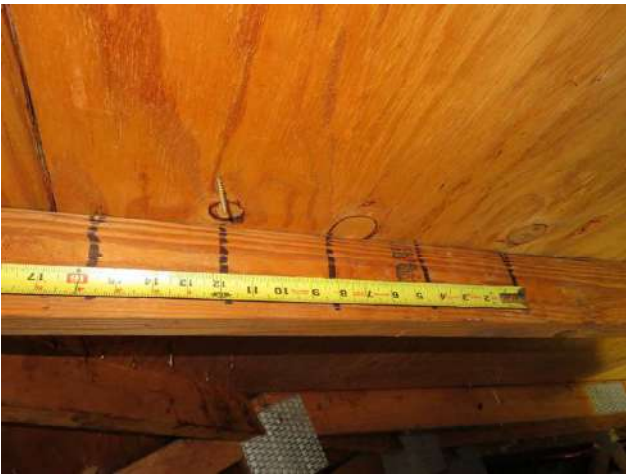
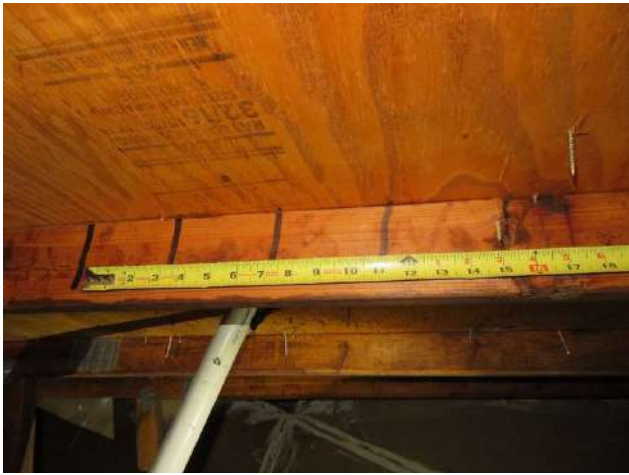
NAIL SPACING - EVERY 6" ON THE EDGES & IN THE FIELD

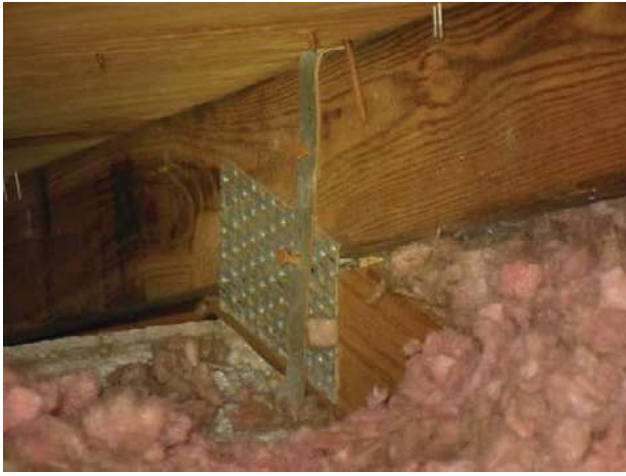
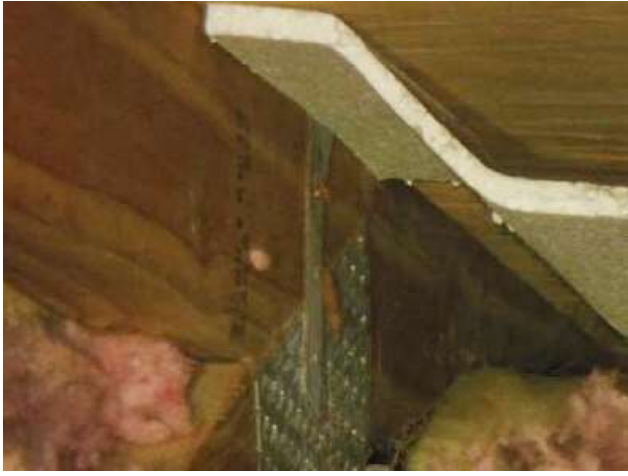
- ☒ Secured to truss/rafter with a minimum of three (3) nails, **and**
- ☒ Attached to the wall top plate of the wall framing, or embedded in the bond beam, with less than a ½" gap from the blocking or truss/rafter **and** blocked no more than 1.5" of the truss/rafter, **and** free of visible severe corrosion.

- ☒ C. Single Wraps
  - Metal connectors consisting of a single strap that wraps over the top of the truss/rafter and is secured with a minimum of 2 nails on the front side and a minimum of 1 nail on the opposing side.

ROOF TO WALL - SINGLE WRAPS

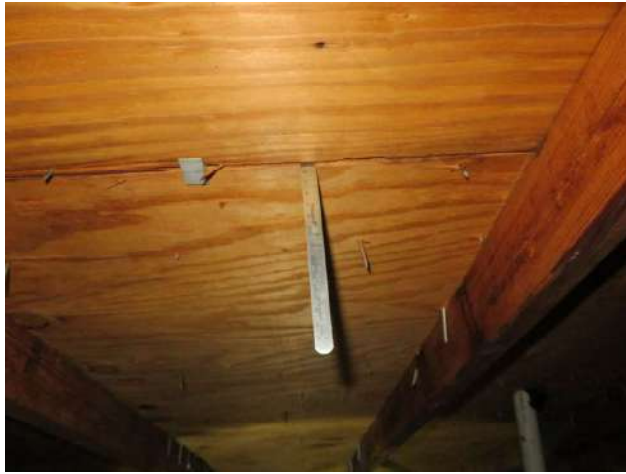
- ☒ A. SWR (also called Sealed Roof Deck) Self-adhering polymer modified-bitumen roofing underlayment applied directly to the sheathing or foam adhesive SWR barrier (not foamed-on insulation) applied as a supplemental means to protect the dwelling from water intrusion in the event of roof covering loss.
- ☐ B. No SWR.
- ☐ C. Unknown or undetermined.

SWR - PEEL N STICK OVER ENTIRE ROOF DECK

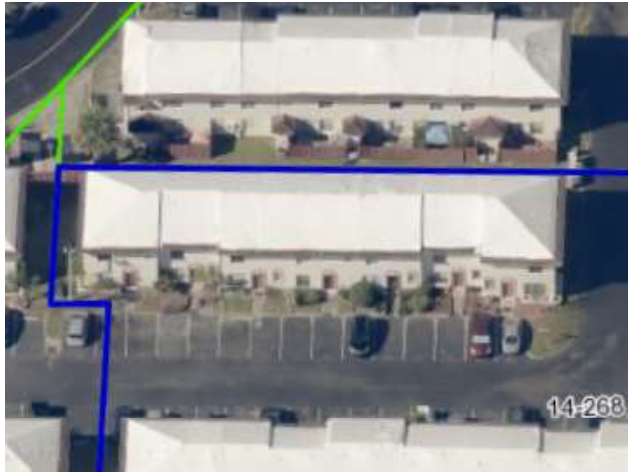
- ☒ A. Hip Roof      Hip roof with no other roof shapes greater than 10% of the total roof system perimeter.  
Total length of non-hip features: \_\_\_\_\_ feet; Total roof system perimeter: \_\_\_\_\_ feet
- ☐ B. Flat Roof      Roof on a building with 5 or more units where at least 90% of the main roof area has a roof slope of less than 2:12. Roof area with slope less than 2:12 \_\_\_\_\_ sq ft; Total roof area \_\_\_\_\_ sq ft
- ☐ C. Other Roof      Any roof that does not qualify as either (A) or (B) above.

AERIAL VIEW SHOWING ALL HIP ROOF
